ROYAL AIRCRAFT ESTABLISHMENT  
TECHNICAL REPORT No. 65158

**CORROSION FATIGUE AND  
STRESS CORROSION CRACKING  
OF AN ALUMINIUM-5%  
MAGNESIUM-4% ZINC ALLOY  
TOTALLY IMMERSED IN 3% NaCl  
AND OTHER CORRODENTS**

Technical Report No. 65158

August 1965

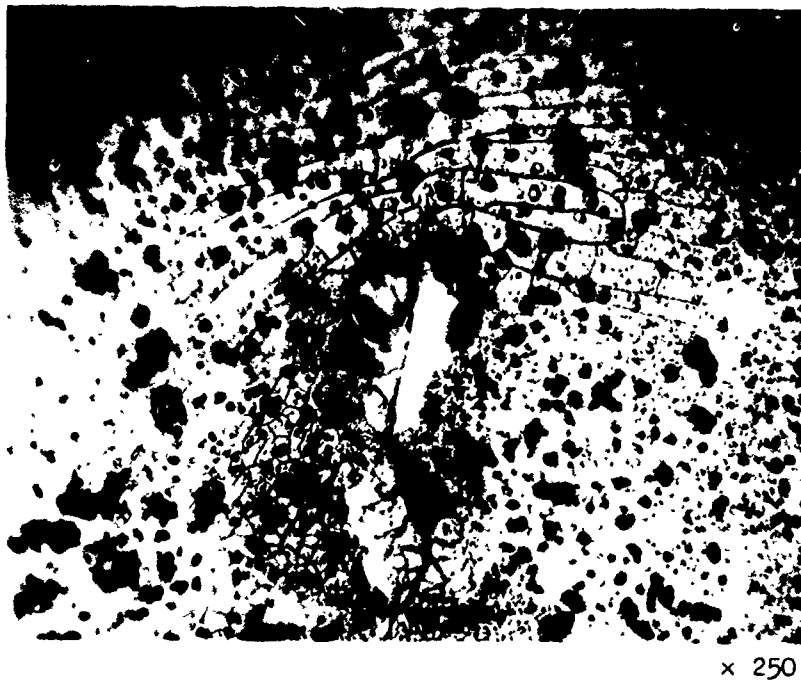
FIG.20 CRAZED SURFACE FILM FORMED NEAR STRESS CORROSION CRACK ORIGIN.

Stress corrosion cracks also originated at grain boundaries under all observed conditions in both heat treatment conditions and as with the corrosion fatigue specimens the 150°C aged material exhibited many more cracks than the 120°C aged material. Unlike the corrosion fatigue specimens no extruded debris was found although a typical cathodic film was formed at a distance from the mouth of each crack as shown in Fig.20.
